### **Home Inspection Report**

### 3313 Y Road, Bellingham, WA

Inspection Date: 12/4/2023

Prepared By: Inside N Out Inspection Services Phone: 360-393-0274

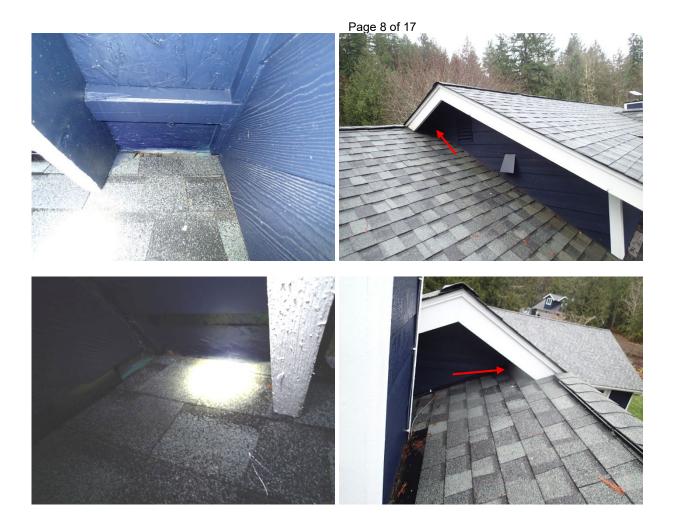
**Repair:** Openings into the attic space from the roof surface are evident where the west living room roof intersects the ridge of the east facing roof (under the overhang along gable wall) at both sides. The openings allow entry for bird or rodent intrusion into the attic. Recommend blocking the openings with wire mesh or other material to prevent any intrusions.

- **5. Repair:** Openings into the attic space from the roof surface are evident where the west living room roof intersects the ridge of the east facing roof (under the overhang along gable wall) at both sides. The openings allow entry for bird or rodent intrusion into the attic. Recommend blocking the openings with wire mesh or other material to prevent any intrusions.
